# **Kirby, Great Broughton and Ingleby Greenhow Local History Group**

## **St Augustine's, Kirkby-in-Cleveland Search for the Foundations of the Saxon Church**

**Dr Jon Kenny MIfA (York Archaeological Trust)  
and  
Roy Parsonage**

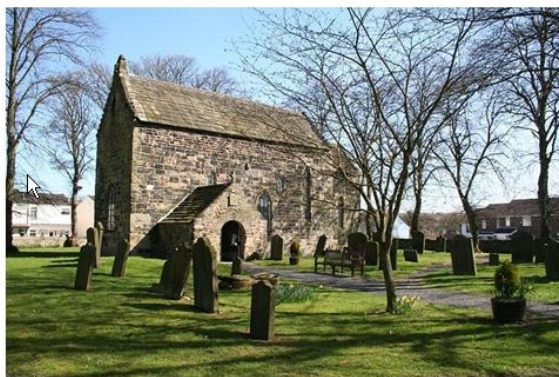
**Figure 3: Rectangular feature with Escomb plan overlaid.**

The results of the survey shown in figure 2 above shows a rectangular feature made up of high resistance anomalies. The rectangle is made up of patches of high resistance and some gaps. This may represent spreads of high resistance material such as stone. The rectangular shape is about 20m in its east west axis and 6m on its north south. This feature might be the outline of an earlier church, possibly foundations and some collapse and tumble. The shape and size of the outline is reminiscent of the church still standing at Escomb in Northumberland See figure 3 below.

Escomb measures  
17.1m x 4.5
